Second Annual Progress Report

CONTACT ION ENGINE SYSTEM  
FOR ATS SATELLITES D AND E  
Contract NAS5-10380

EOS Report 7202-A-2

1 July 1969

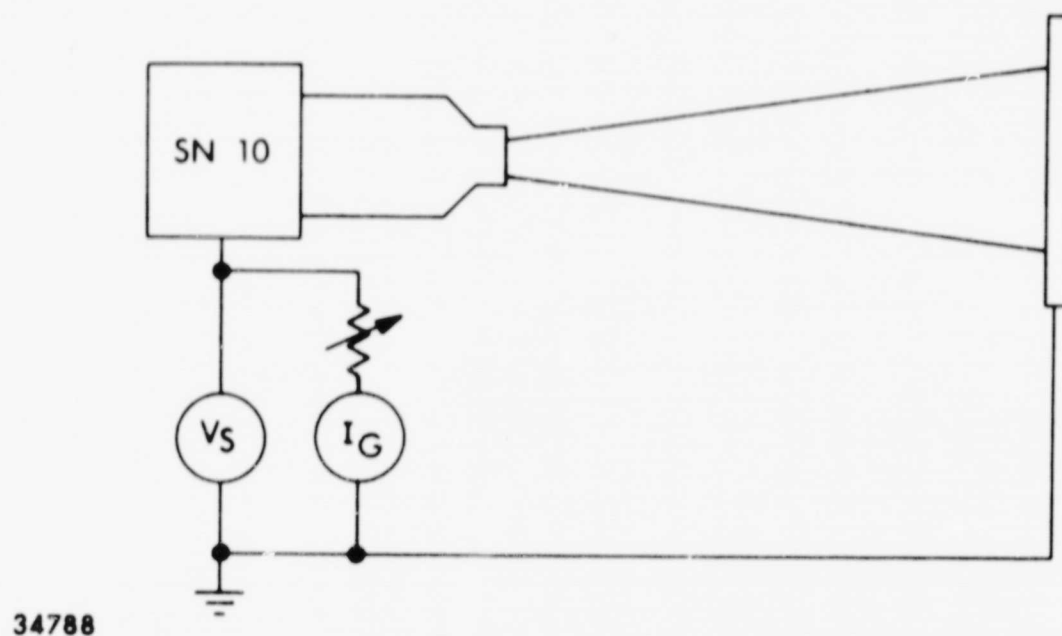
Figure 1. Experimental Setup

In the course of studying the neutralizer data received from ion engine test No. 5, a number of tests were conducted on laboratory microthruster hardware. In one test, the effect of reduced neutralizer emission requirements (such as produced by ram ion current in orbit) on microthruster floating potential was measured. The experimental setup and data obtained are shown in Fig. 1 and Table I.

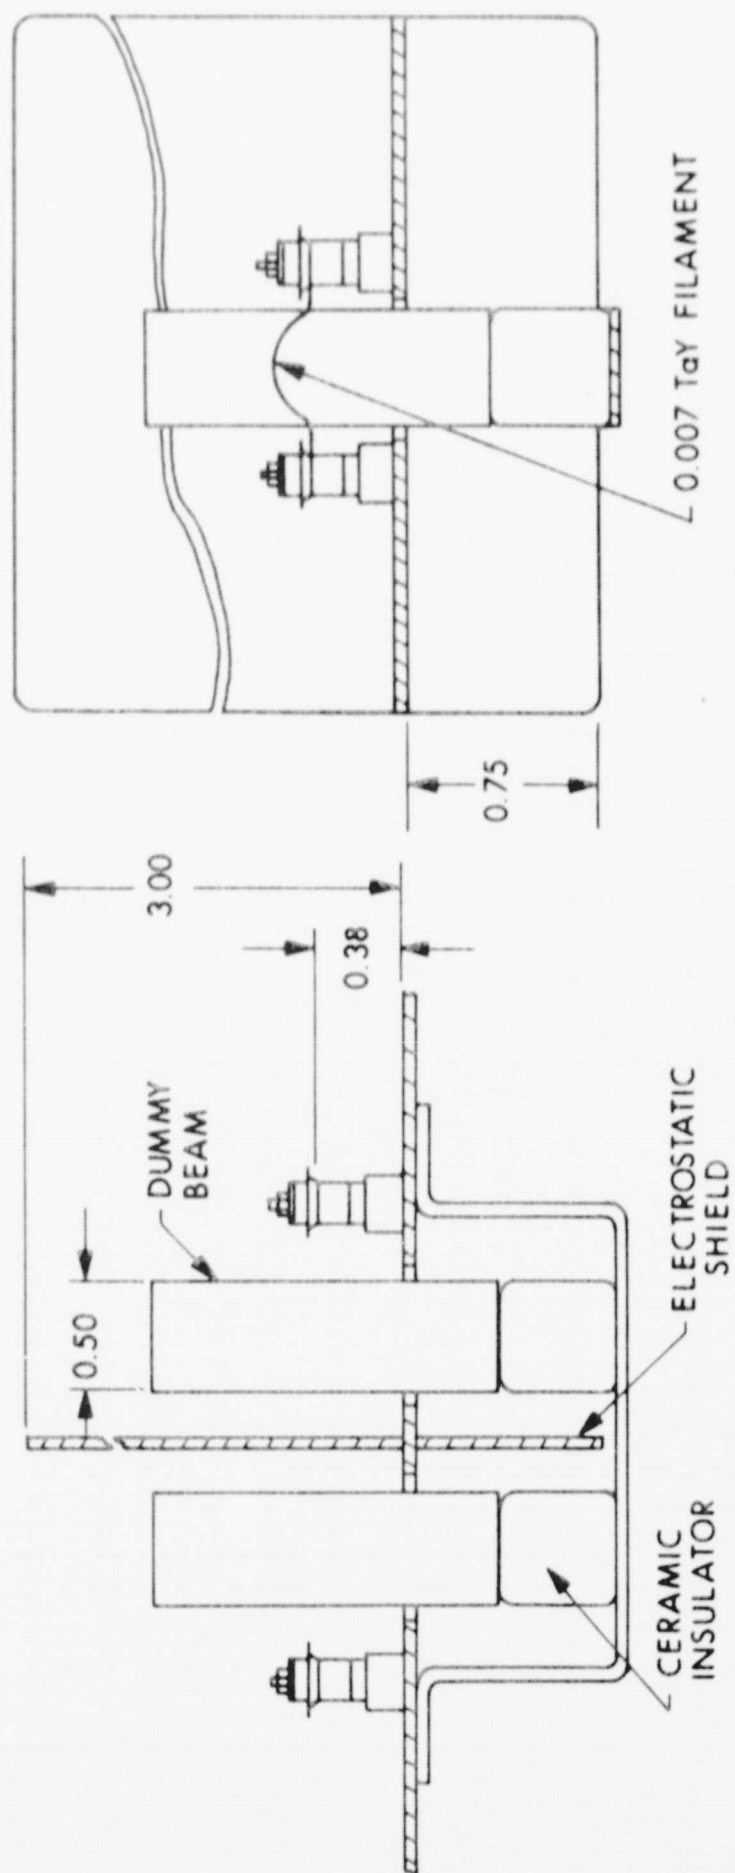
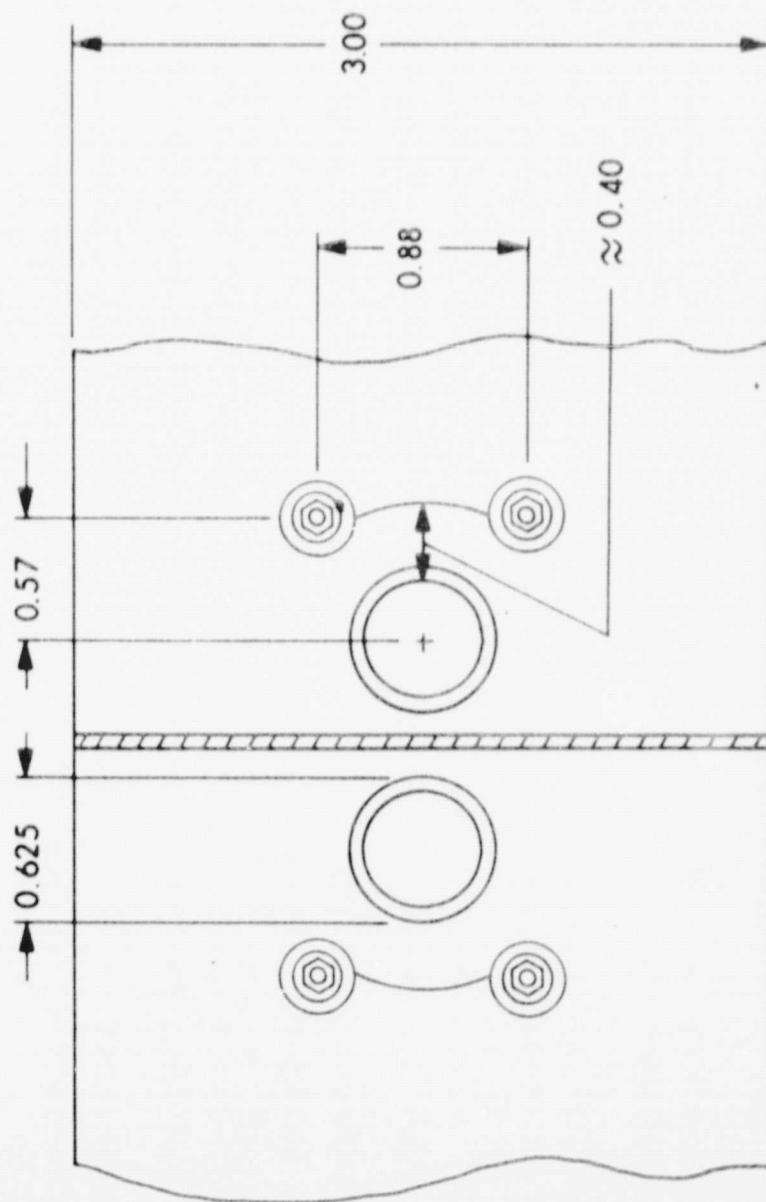
Figure 2. Experimental Neutralizer Configuration

To investigate the effect of the absence of electric field on subsequent neutralizer emission, two 0.007-inch-diameter Ta-Y neutralizers were assembled on a test fixture duplicating the ATS microthruster experiment. A metal rod was used to simulate the cesium ion beam. The experimental setup is shown in Fig. 2. The filaments were placed in a 1' x 3' vacuum
